# **Inspection Report**

Product model: R32-JSS

Product name: Hydraulic excavator driver protection device

Entrusting unit: Shandong Lipai Machinery Group Co., LTD

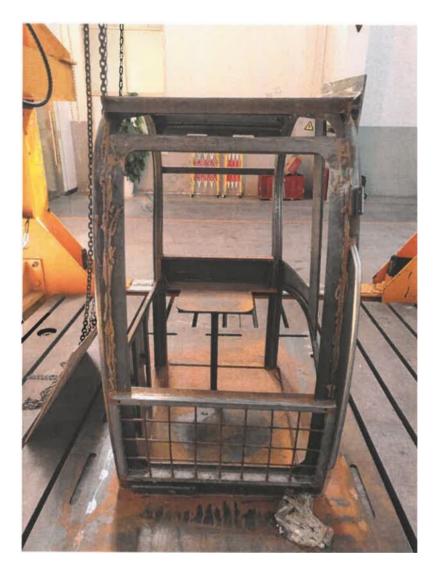
R32-JSS type hydraulic excavator driver protection device is developed by Shandong Lipai Machinery Group Co., LTD.

Photo of the Sample

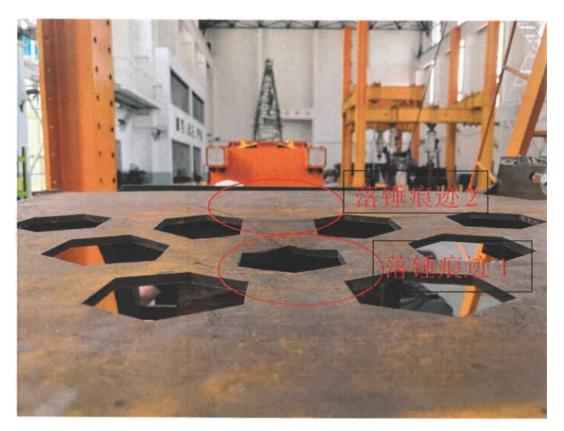
order nu- mber	inspecting item	Design or standard requirements	result	conclus- ion	remarks
1	Energy absorption capacity of top protection device	The top protection device shall not penetrate the DLV under initial or subsequent impact under the 1365J energy reference	After the hammer impact energy of 1365J, the top protection device was not penetrated after impact. The maximum vertical residual deformation of the top protection device at location 1 of the hammer was 34 mm, and that at location 2 of the hammer was 11mm. The top protection device did not invade DLV	qualified

Photo-F-1 Hammer drop test

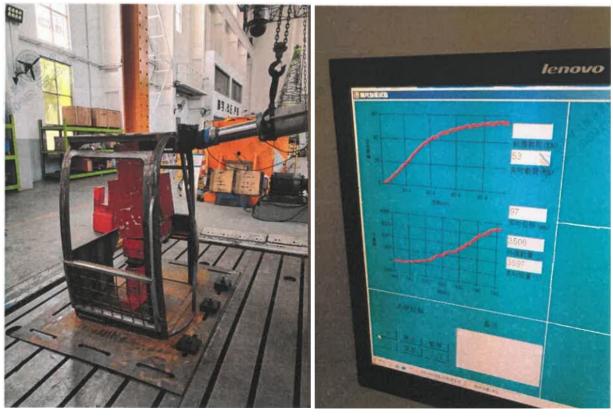
ord mb	ler nu- oer	inspecting item	Design or standard requirements	result	conclus- ion	remarks
	1	Invert the lateral energy absorption capacity of the protective structure	The absorbed energy is not less than 3500J, and the tipping protection structure does not invade DLV	When the loading force is 53kN, the displacement of the loading point is 97mm, and the absorbed energy reaches 3597J. The tipping protection structure does not invade DLV	qualified

Photo F-2 lateral loading test

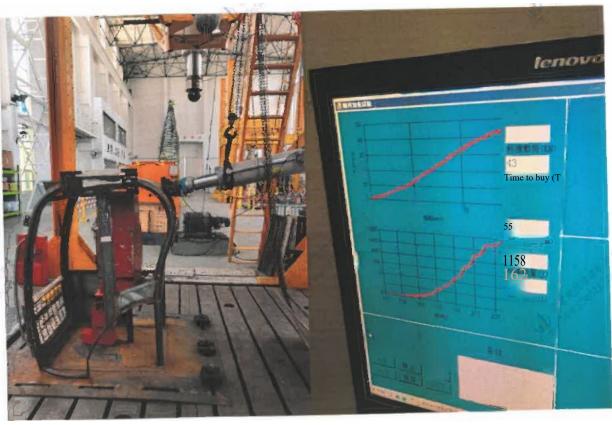
orde nun	inspecting item	Design or standard requirements	result	conclus- ion	remarks
1	Flip the protective cover Construct vertical energy absorption capacity	The absorbed energy is not less than 1158J, and the protective structure does not invade DLV	The loading point displacement is 55mm, the absorbed energy reaches 1162J, and the protective structure does not invade DLV	qualified

Photo F-3 vertical loading test

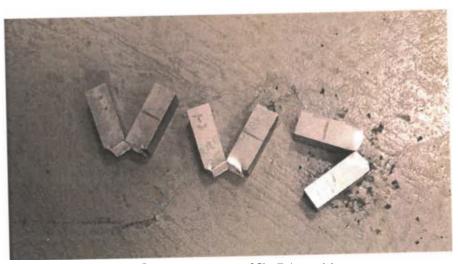
order nu- mber	inspecting item		Design or standard requirements	result	conclus- ion	remarks
1	The material is cold trial	Height of specimen (10mm×10mm×55mm)	The absorption capacity is at least 11J	31Ј	qualified	V-shaped notch pen- dulum im- pact, test temperature -30°C

Low temperature test of film F-4 material
