No.: GGJ06.2020.MY34.02.4545

# Test Report

Product Name: Protection device for agricultural excavator

Product Type : 32

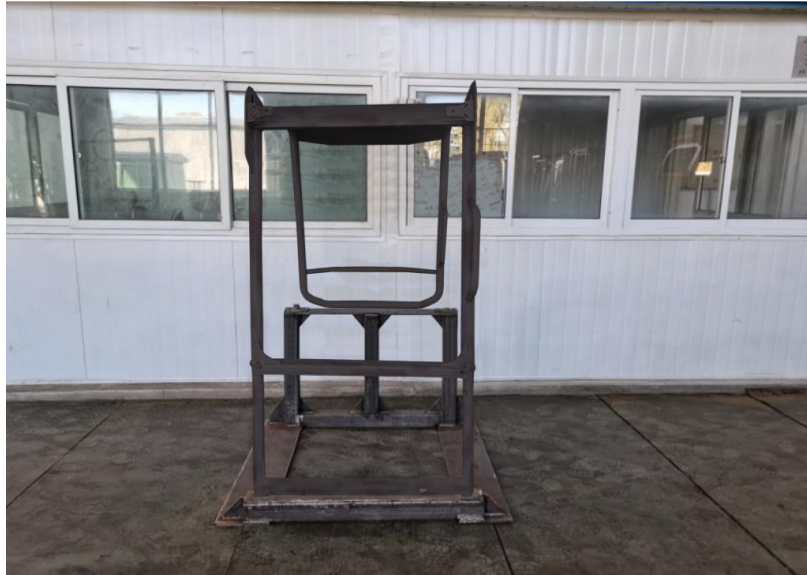
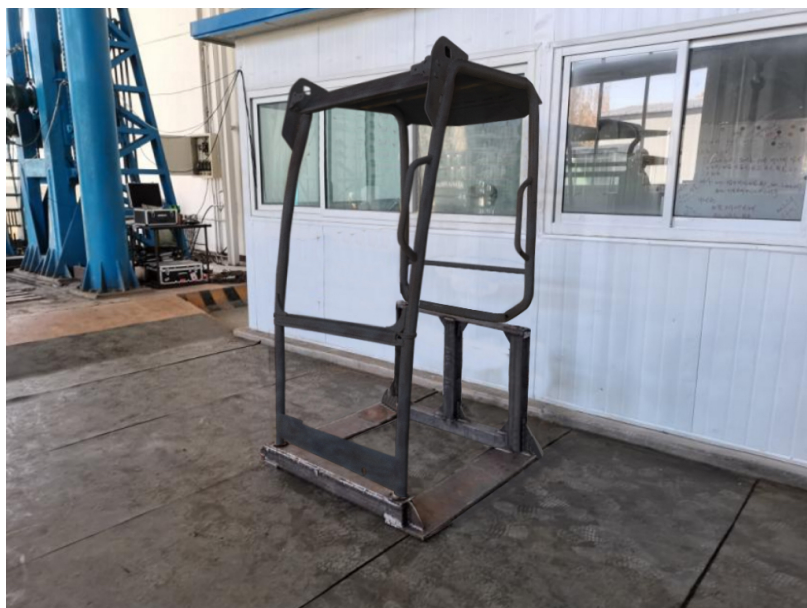
Figure A1 sample appearance

The TOPS is produced and designed by Shandong Rippa Machinery Group Co., Ltd.. It is suitable for the Shandong Rippa Machinery Group Co., Ltd. NDI335 Agricultural excavator. The sample is in a normal state before test.

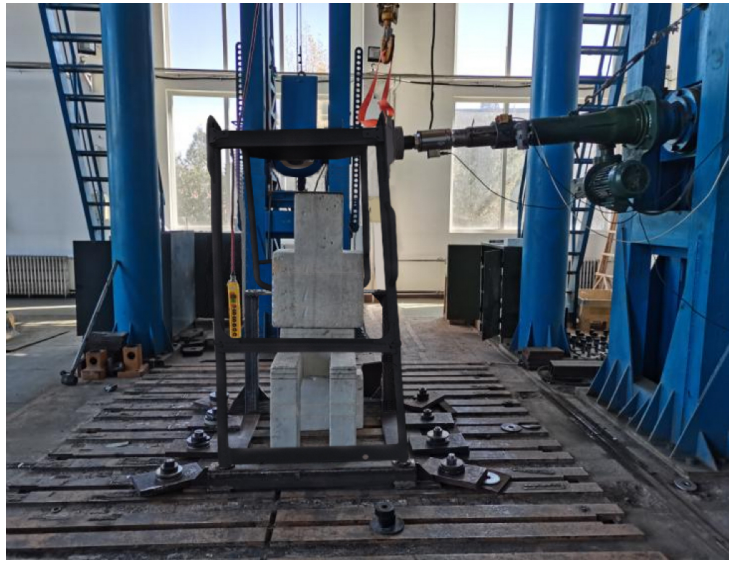
Figure. F2 After the lateral loading test

The state of Lateral load see appendix Figure F1, the end of Lateral load see appendix Figure F2, Load force ,displacement and energy data and the curves are shown in Table D2 and the curves of Force-displacement and Force-energy are shown in Figure.D3, Figure.D4.

The maximum lateral load force is 22.0kN and maximum lateral load energy is 1182J. After testing, the lateral displacement of Tip-over protection structure's components is 79mm. The deformation of any part of TOPS or the simulated ground plane did not invade the DLV.
