No.: GGJ06.2021.MY34.02.3855

# Test Report

Product Name: Protection device for agricultural excavator

Product Type : 55

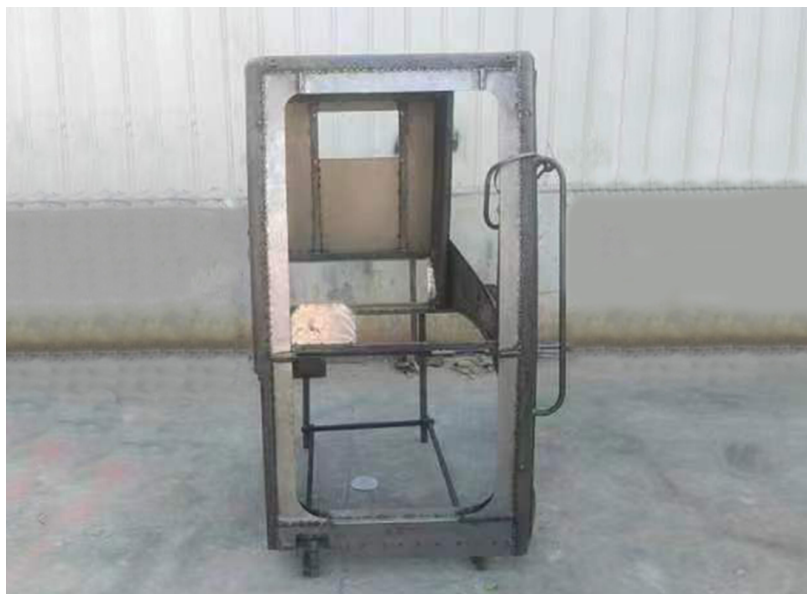
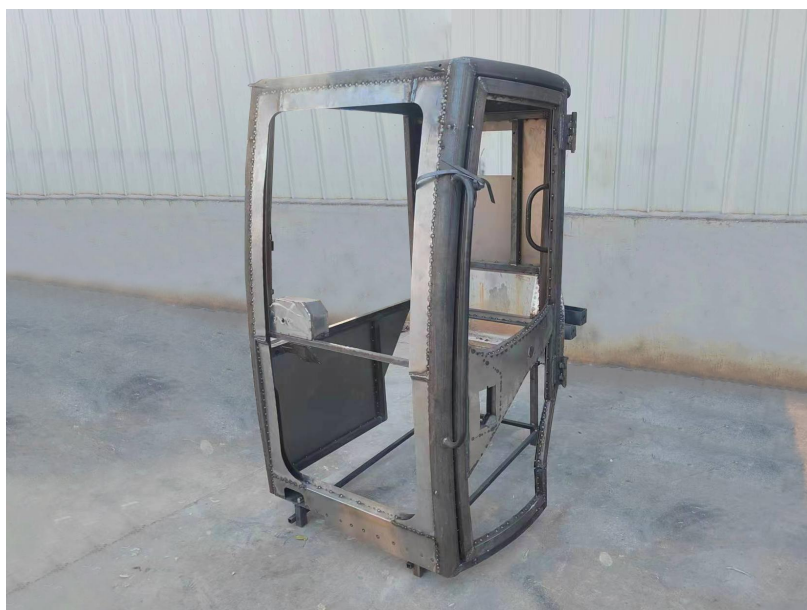
Figure A1 sample appearance

The TOPS is produced and designed by Shandong Rippa Machinery Group Co., Ltd.. It is suitable for the Shandong Rippa Machinery Group Co., Ltd. NDI355 Agricultural excavator. The sample is in a normal state before test.

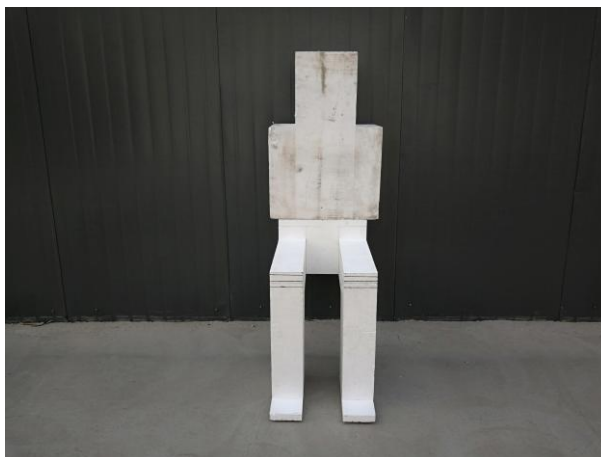
Figure D1 Deflection-limiting Volume

According to ISO 3164:2013, we have fixed DLV, see figure D1. The location of DLV in the TOPS, see figure D2.
