Report number: GJ-70242-2025

Inspection Report

Product model: R18-DP

Product name: Hydraulic excavator driver protection device

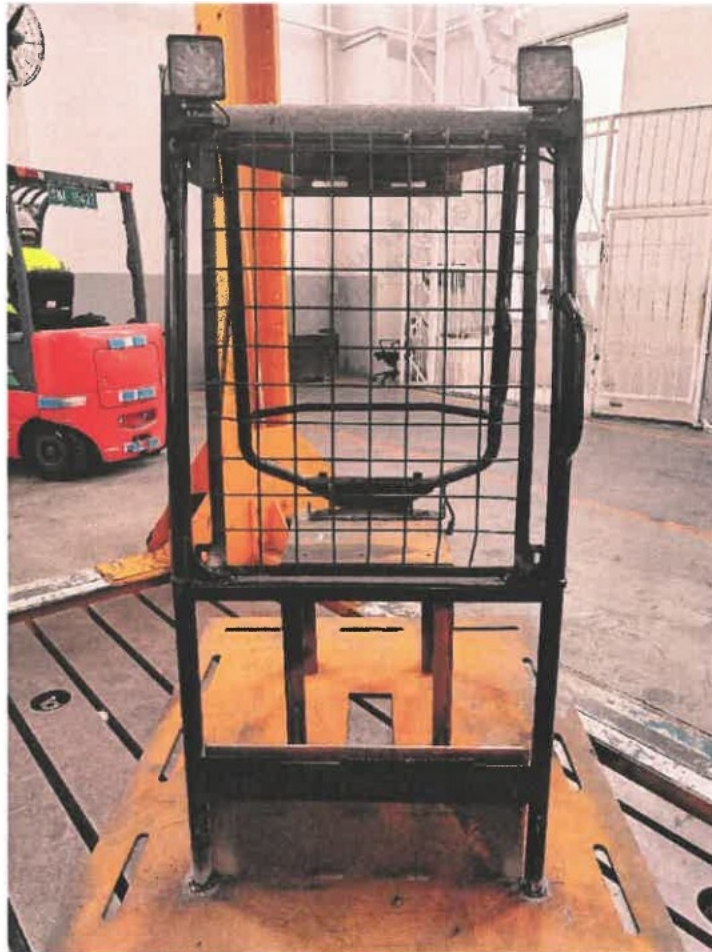
Photo of the Sample

R18-DP type hydraulic excavator driver protection device is developed by Shandong Lipai Machinery Group Co., LTD.

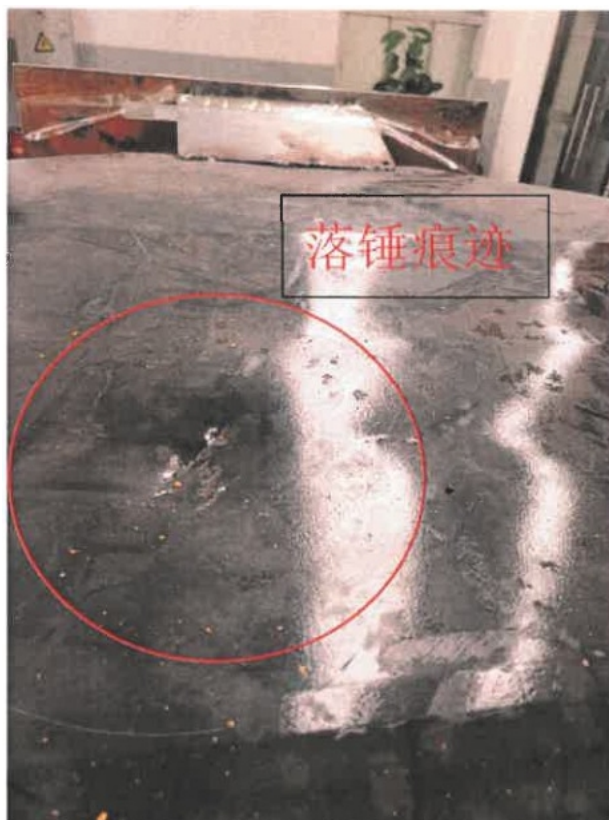
Photo-F-1 Hammer drop test

order number	inspecting item	Design or standard requirements	result	conclusion	remarks
1	Energy absorption capacity of top protection device	The top protection device shall not penetrate the DLV under initial or subsequent impact under the 1365J energy reference	After the hammer impact energy of 1365 J, the top protection device was not penetrated after impact, the maximum vertical residual deformation of the top protection device was 27mm, and the top protection device did not invade DLV	qualified
