| <b>Prüfgegenstand:</b><br>Test item: | <b>Hydraulic Excavator</b> | | | |
| <b>Bezeichnung / Typ-Nr.:</b><br>Identification / Type no.: | <b>R18</b> | | | |
| <b>Auftrags-Inhalt:</b><br>Order content: | <b>EMC test</b> | | | |
| <b>Prüfgrundlage:</b><br>Test specification: | [Emission] with reference to: EN ISO 13766-1:2018<br>[Immunity] with reference to: EN ISO 13766-1:2018<br>ISO 10605:2008<br>IEC 61800-3:2004+A1, Clause A.3.2.2 | | | |

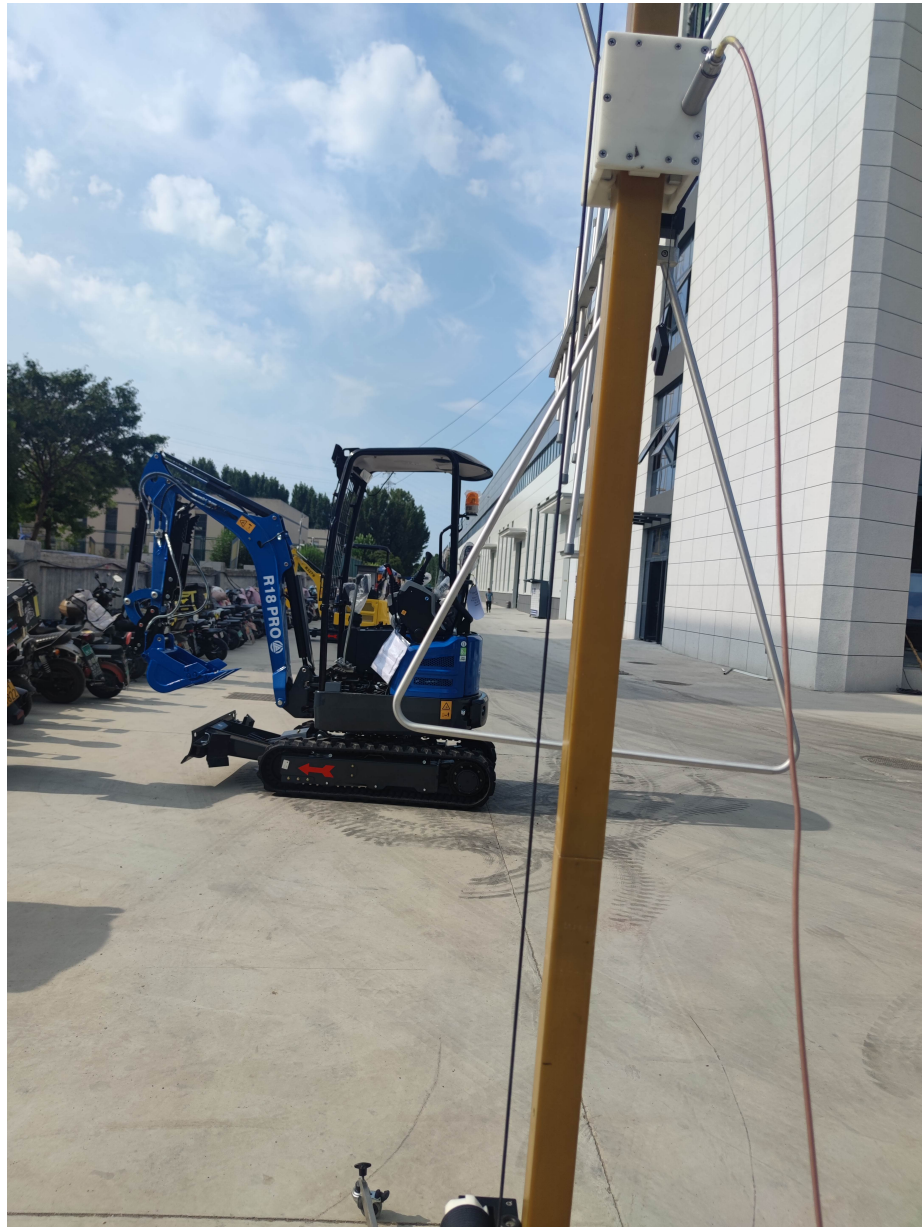
**Photograph 1: Set-up for radiated electromagnetic disturbances above 30MHz**

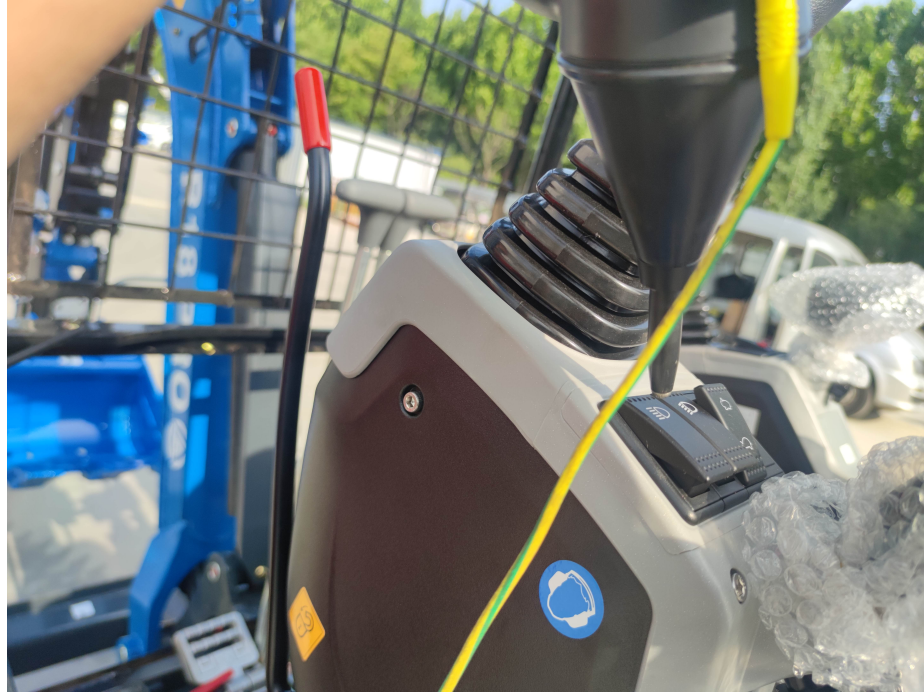
**Photograph 2: Set-up for immunity test of ESD**

The immunity against electrostatic discharge was tested in accordance with EN ISO 13766-1:2018. Test setup and ESD-Generator are according to ISO 10605:2008 which is specified by EN ISO 13766-1:2018.

Charge voltage :  $\pm 4.0\text{kV}$ ,  $\pm 6.0\text{kV}$  (Contact Discharge)  
 $\pm 4.0\text{kV}$ ,  $\pm 8.0\text{kV}$  (Air Discharge)  
Generator capacitance : 330 pF (inside of the machinery)  
150 pF (outside of the machinery)  
Polarity : positive / negative  
Number of discharges : >10 at each point  
Operation mode : Engine and all electronic systems on  
Performance criteria : Class A( $\pm 4.0\text{kV}$  Contact and Air discharge)  
Class C( $\pm 6.0\text{kV}$  Contact discharge and  $\pm 8.0\text{kV}$  Air discharge)

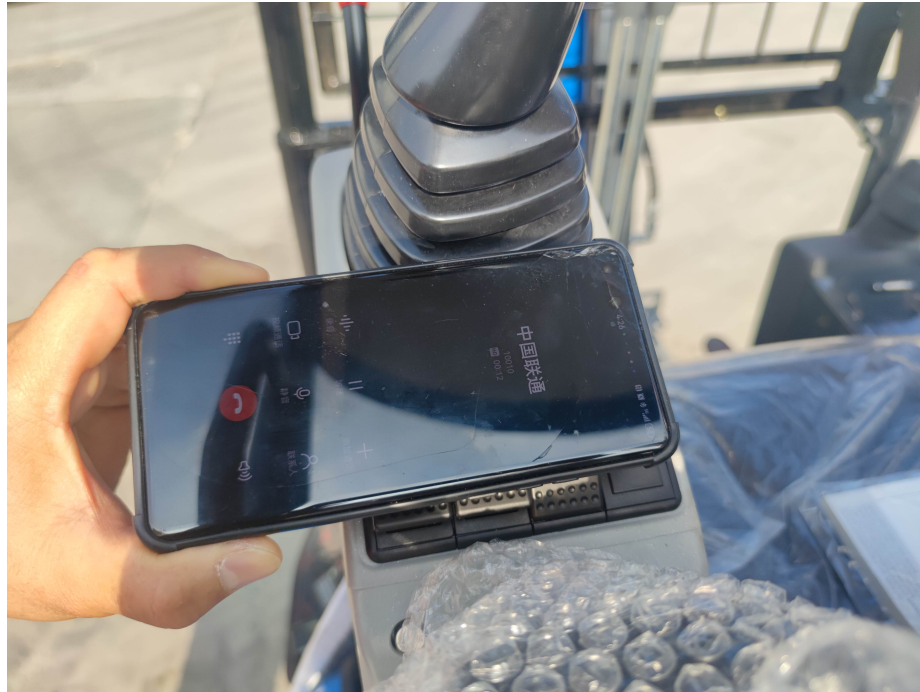
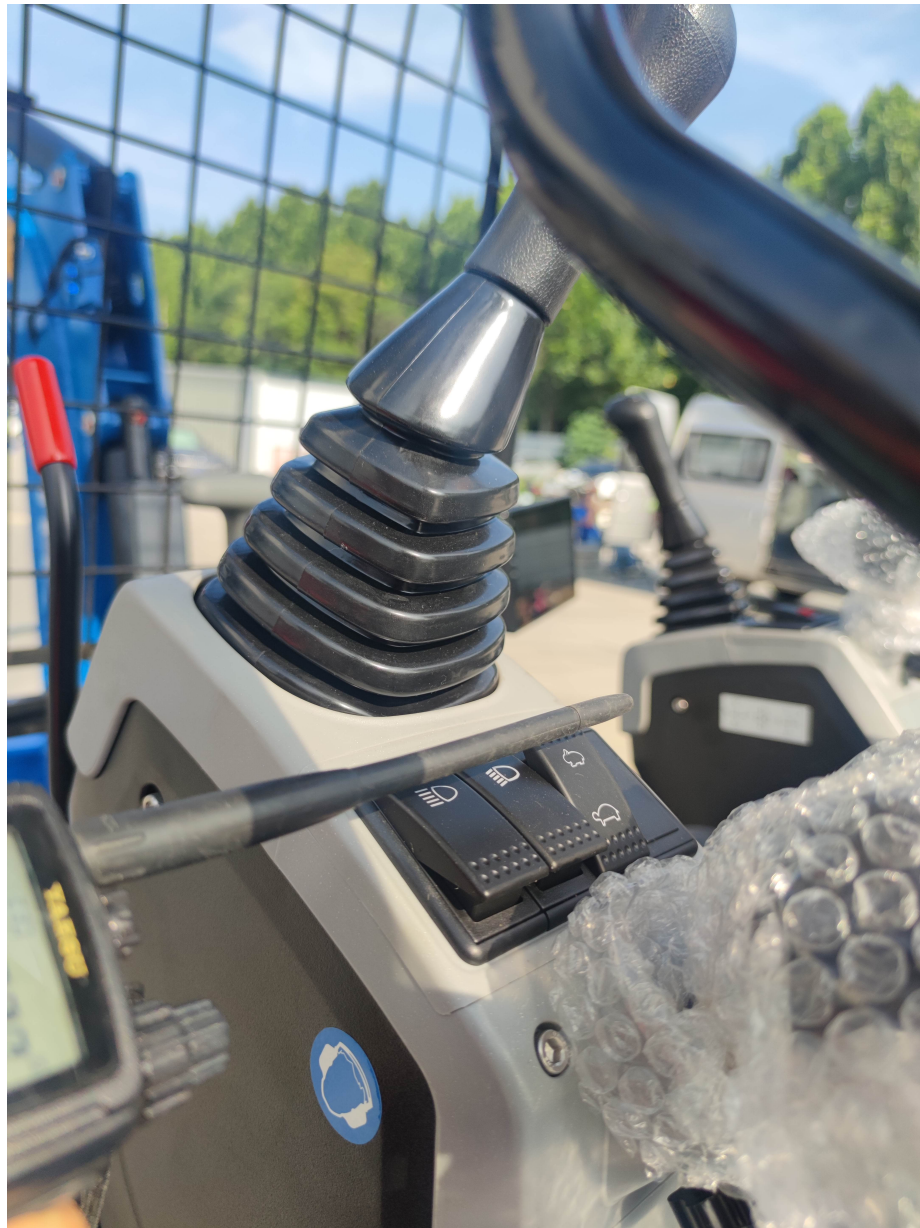
**Photograph 3: Set-up for radio frequency electromagnetic field**

| Test level | : 30V/m |
| Test frequencies | : 52MHz: ISM frequency<br>145MHz: business radio band<br>435MHz: ISM frequency<br>915MHz: GSM915 |
