| <b>Prüfbericht-Nr.:</b><br>Test report no.: | <b>CN25MEMD 001</b> | <b>Auftrags-Nr.:</b><br>Order no.: | <b>178224841</b> | Seite 1 von 31<br>Page 1 of 31 |
| <b>Prüfgegenstand:</b><br>Test item: | <b>Hydraulic Excavator</b> | | | |
| <b>Bezeichnung / Typ-Nr.:</b><br>Identification / Type no.: | <b>R330, R22</b> | | | |
| <b>Auftrags-Inhalt:</b><br>Order content: | <b>EMC test</b> | | | |

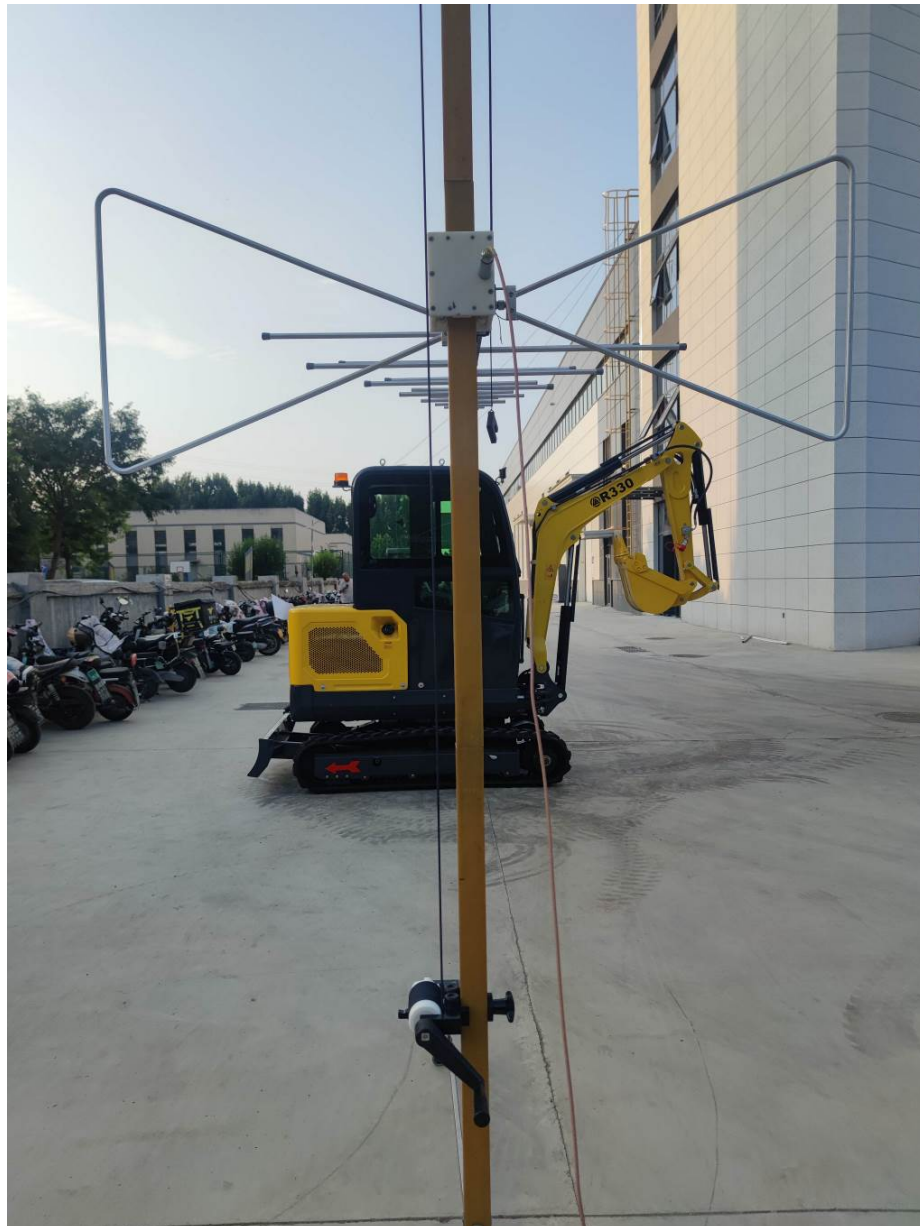
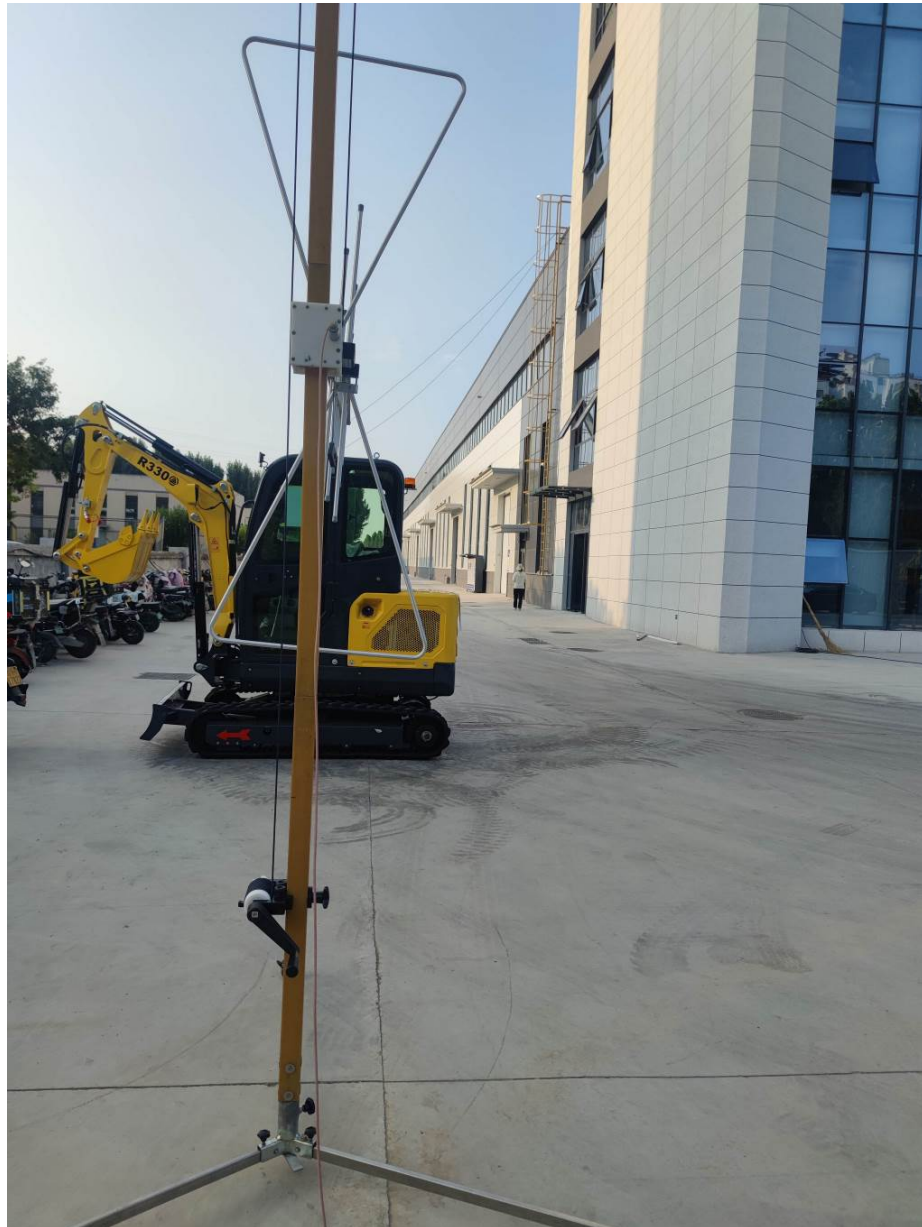
**Photograph 1: Set-up for radiated electromagnetic disturbances above 30MHz**

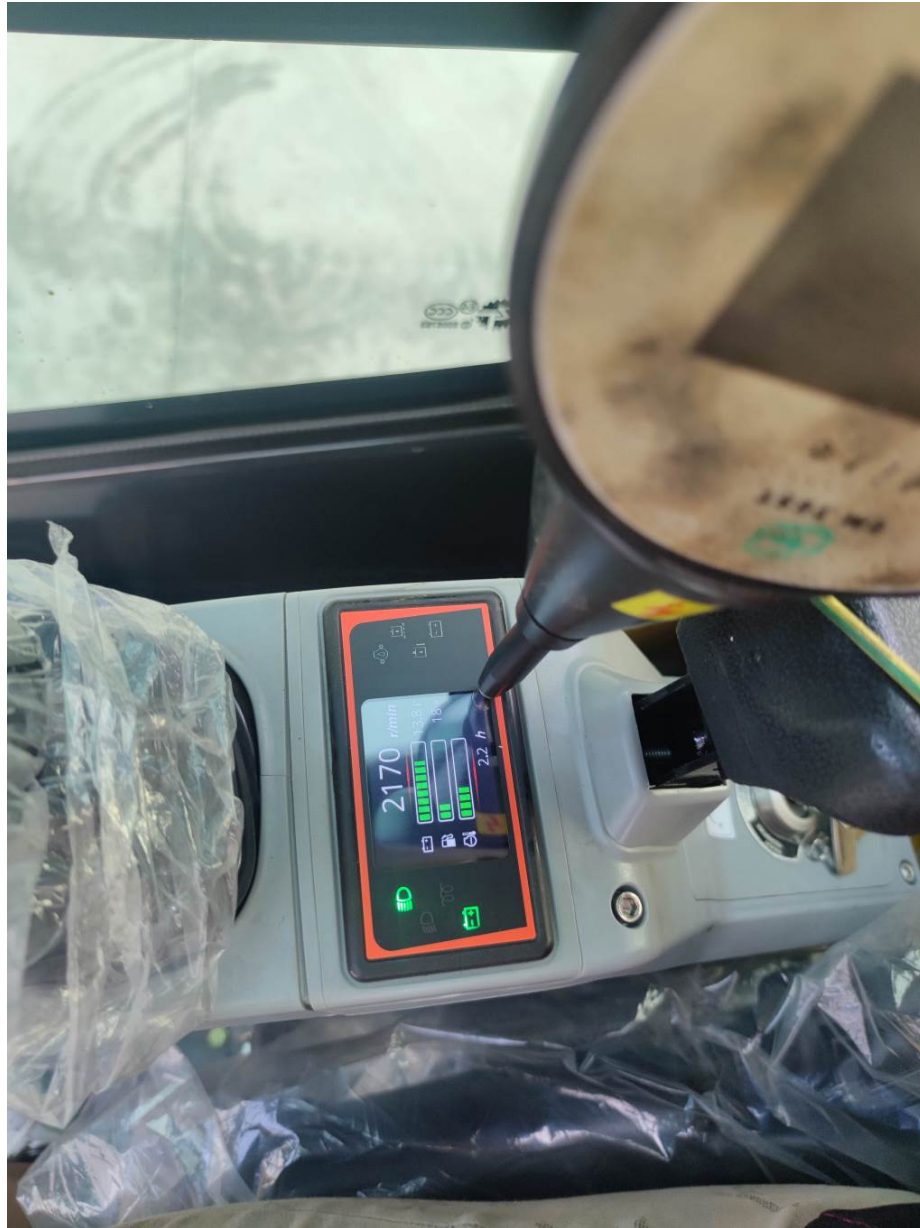
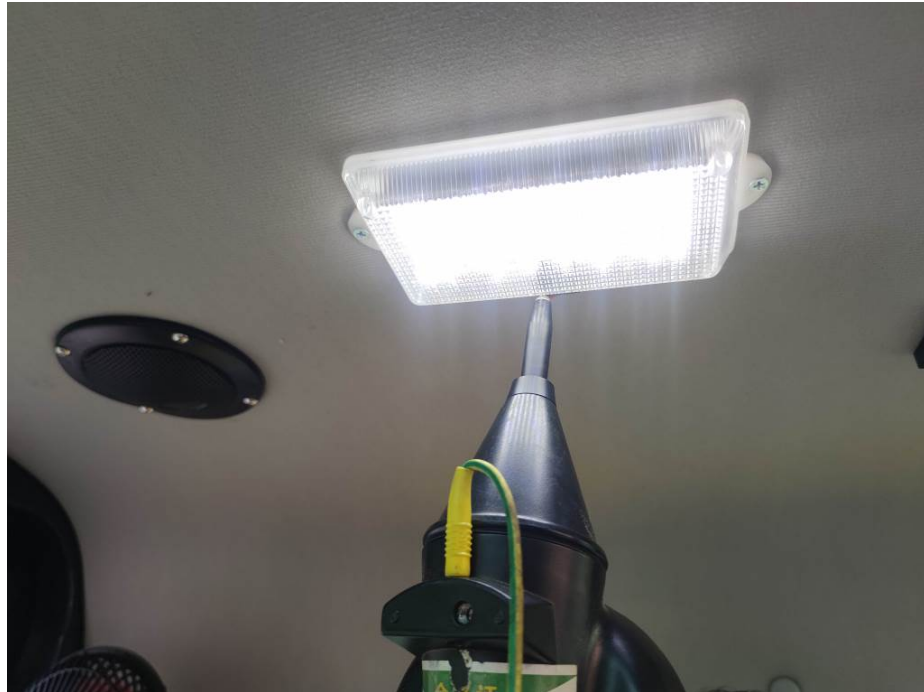
**Photograph 2: Set-up for immunity test of ESD**

The immunity against electrostatic discharge was tested in accordance with EN ISO 13766-1:2018. Test setup and ESD-Generator are according to ISO 10605:2008 which is specified by EN ISO 13766-1:2018.

Charge voltage :  $\pm 4.0\text{kV}$ ,  $\pm 6.0\text{kV}$  (Contact Discharge)  
 $\pm 4.0\text{kV}$ ,  $\pm 8.0\text{kV}$  (Air Discharge)  
Generator capacitance : 330 pF (inside of the machinery)  
150 pF (outside of the machinery)  
Polarity : positive / negative  
Number of discharges : >10 at each point  
Operation mode : Engine and all electronic systems on  
Performance criteria : Class A( $\pm 4.0\text{kV}$  Contact and Air discharge)  
Class C( $\pm 6.0\text{kV}$  Contact discharge and  $\pm 8.0\text{kV}$  Air discharge)

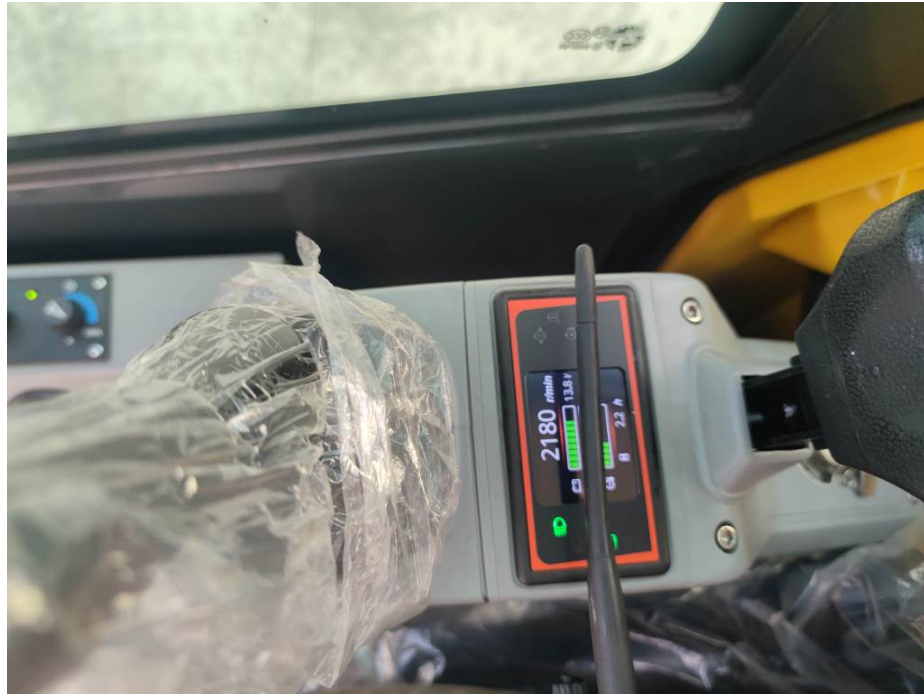
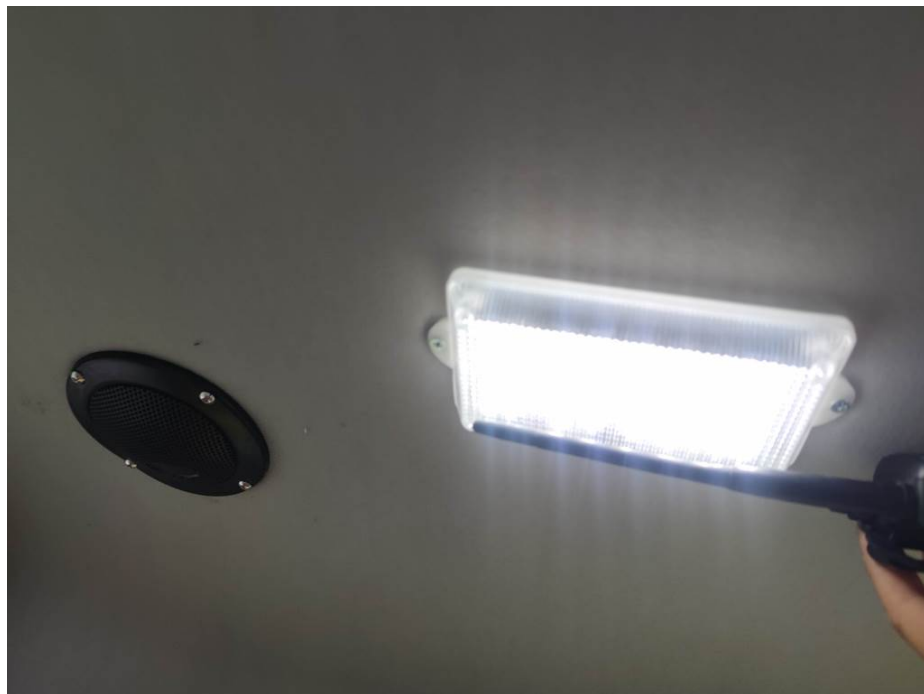
**Photograph 3: Set-up for radio frequency electromagnetic field**

According to clause A.3.2.2 of IEC 61800-3:2004+A1, the test was only performed at some discrete frequencies.

| Test frequencies | : 52MHz: ISM frequency<br>145MHz: business radio band<br>435MHz: ISM frequency<br>915MHz: GSM915 |
